SUBJECT: Operational Report - Lessons Learned, Headquarters, 84th
Engineer Battalion, for Period Ending 30 April 1970

DEPARTMENT OF THE ARMY
HEADQUARTERS, 84TH ENGINEER BATTALION (CONSTRUCTION)
APO SAN FRANCISCO 96238

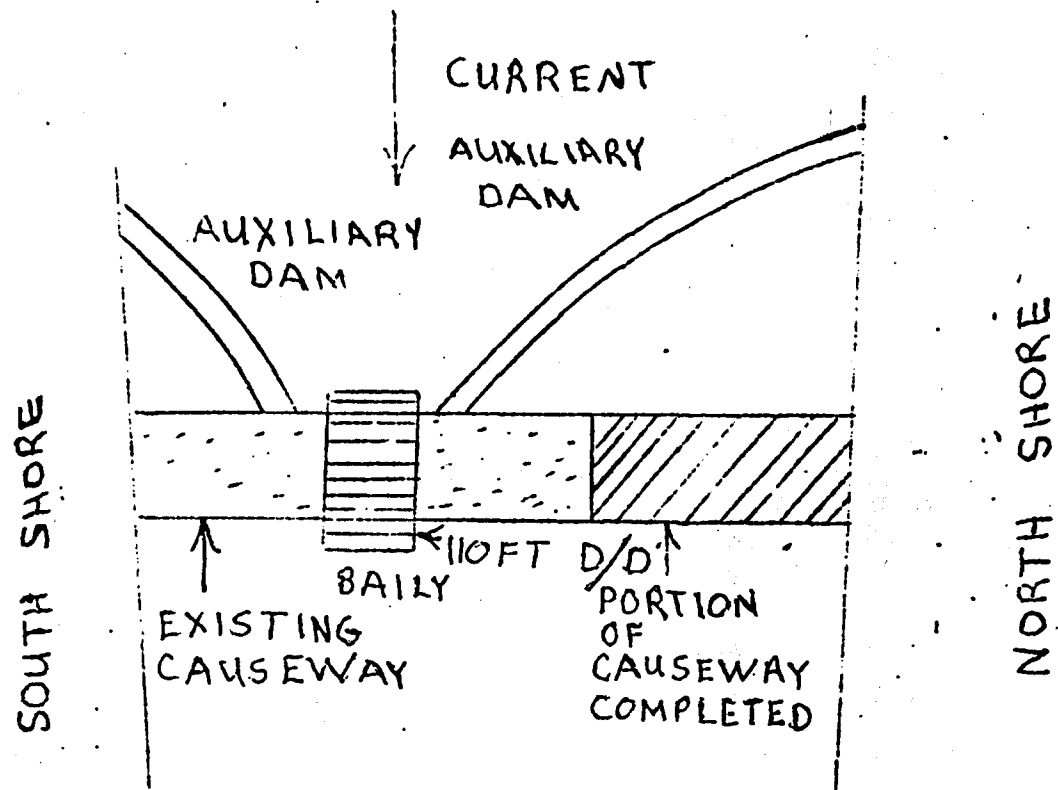
CAUSEWAY

BONG SON BRIDGE

This project, one of the most ambitious projects the 84th Engr Bn (Const) has undertaken in Vietnam, consists of the construction of a 1634.5 ft long bridge. During this quarter, the flow of water in the main channel of the Song Lai Giang River was diverted and a construction causeway was completed. 245 piles were driven to resistance for a total of 248 driven to date. A total of 312 piles are required for construction of the bridge. Fourteen of the 26 reinforced concrete pile caps required were cast in place. One abutment was completed and three spans of stringers were set in place.
